# RSH350

## Rear Seal Conversion Adaptor

### Conversion Rear Main Seal Holders

Chevrolet 1986-Up, V6 262 CID & V8 Small Block

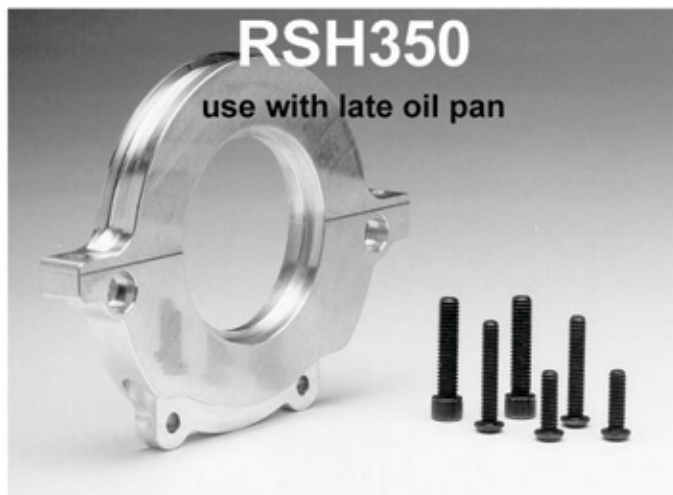
The choice is yours - use late style oil pan. Enables a rebuilder to install a 2-pc. design crankshaft in a 1-pc. seal design application. Manufactured from billet aluminum.
